A6 MARR Clay Lane Junction Safety Report

Our Reference A6MARR-0-S-52-001-RE-001

A6 MARR El29 - CPO Objection Clay Lane Alternative Layout

Safety Statement

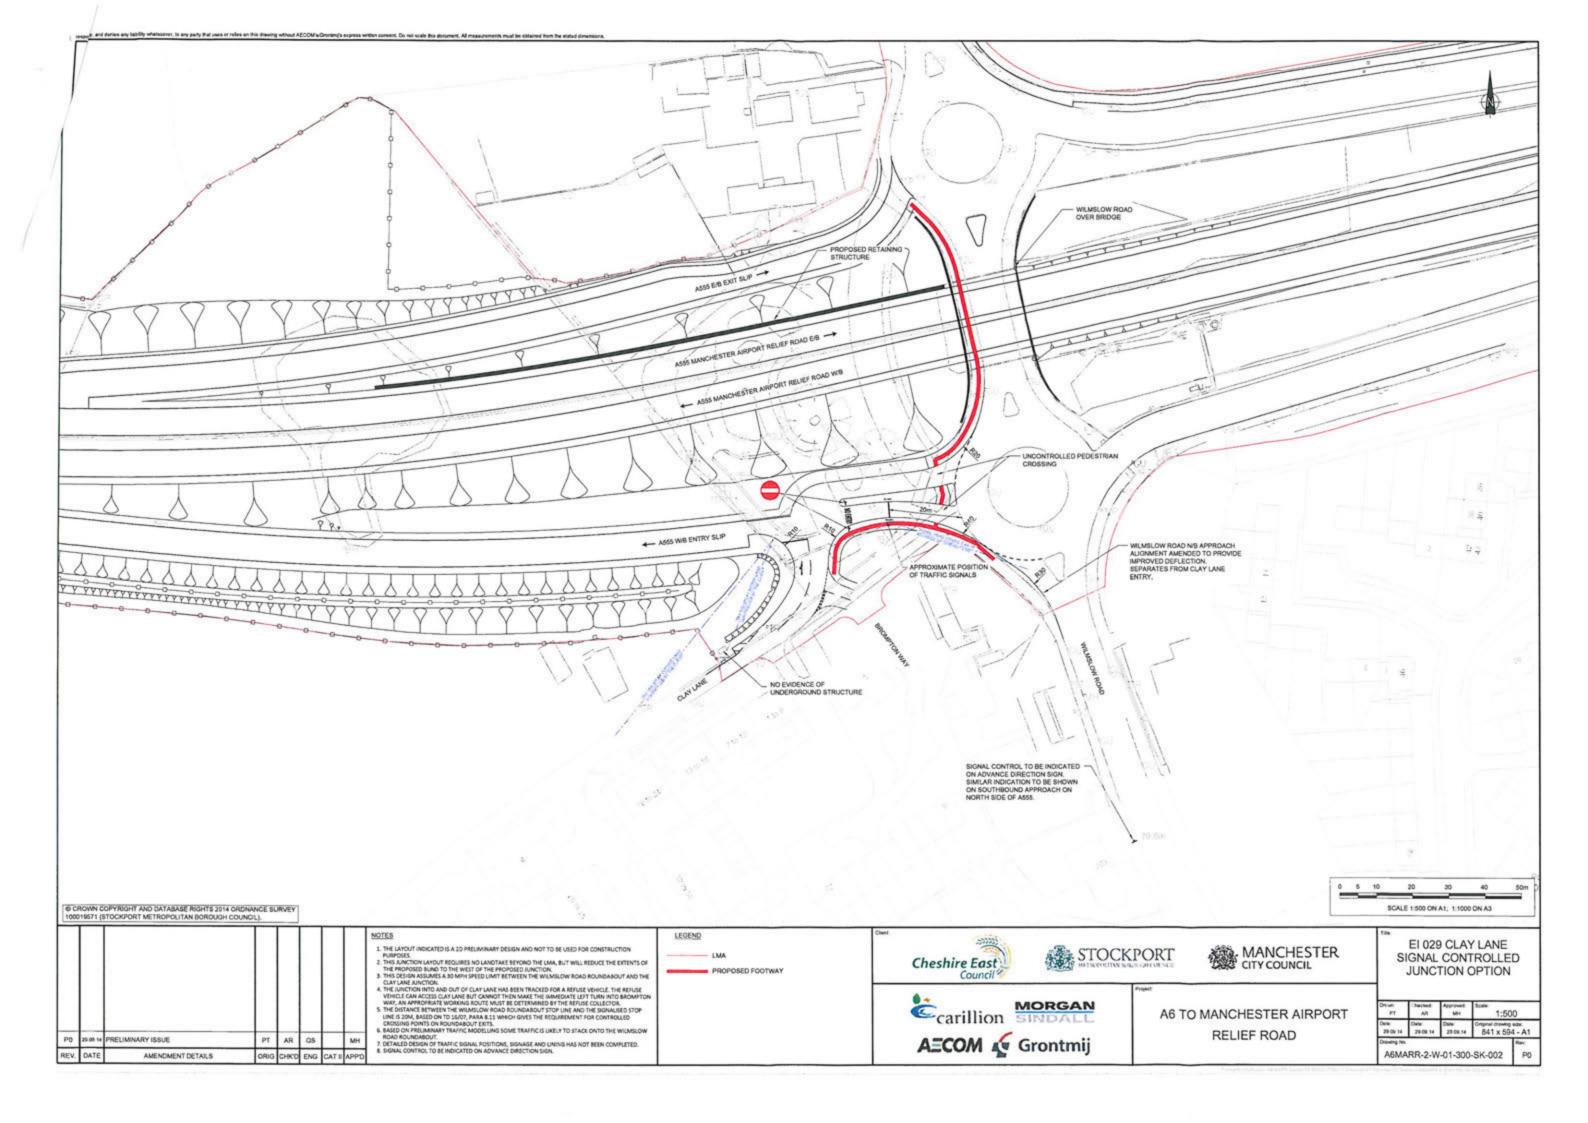
Finally, the design of the exit from the slip road suggests two-way traffic is likely. The photo below, shows Clay Lane to be narrow, and unable to accommodate two-way traffic, potentially leading to head-on collisions on Clay Lane.
