83 - 85 Stanley Road, Cheadle Hulme Greater Manchester

Historic Building Recording

Ref: 107971.02
October 2018

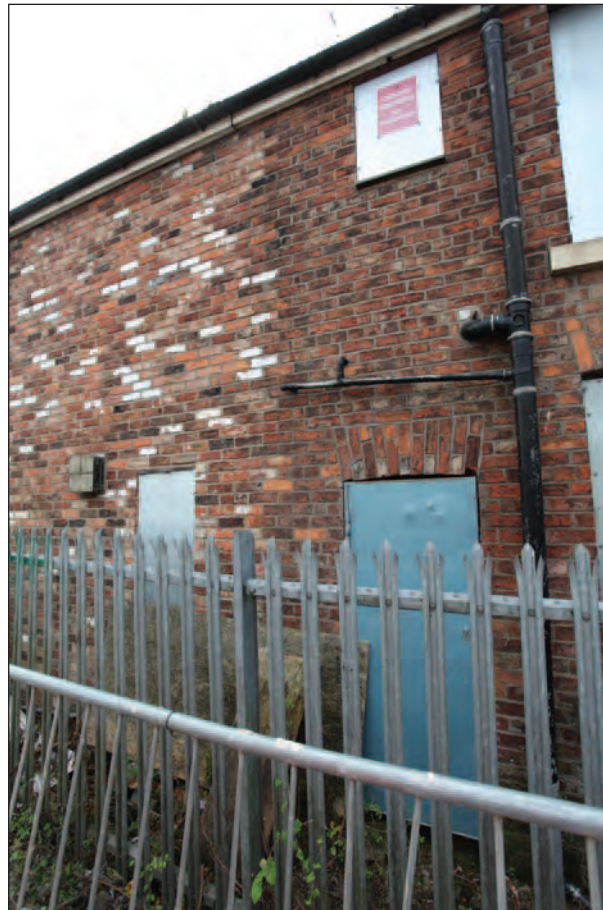
Plate 3: Eastern end of the north elevation of number 83, with vertical construction joint

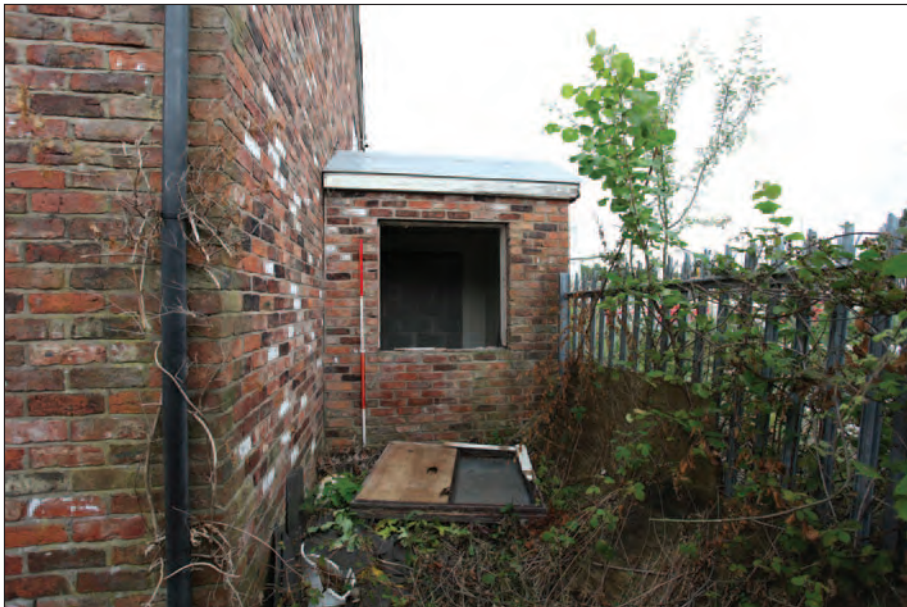
Plate 8: East elevation with porch viewed from the south

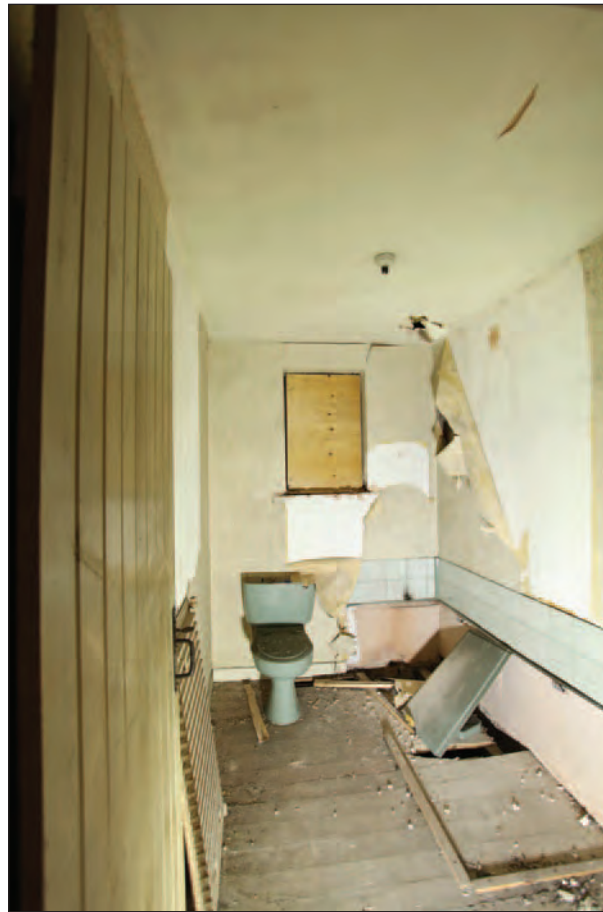
- 3.3.11 The first floor (Figure 6) was accessed from a straight timber staircase which led to a small landing (F1) built with stud partition walls with plain doorways to the adjoining rooms. Room F2 was deemed unsafe to enter due to water ingress. Nevertheless, this was viewed from the doorway revealing that it contained an open fireplace, although its surround had been removed, within the west wall. A timber window was also identified within the north wall (Plate 14). Immediately to the east there was a small bathroom with a boarded-up inserted window opening within the north wall (Plate 15).

Plate 15: Number 83, bathroom F3 viewed from the south

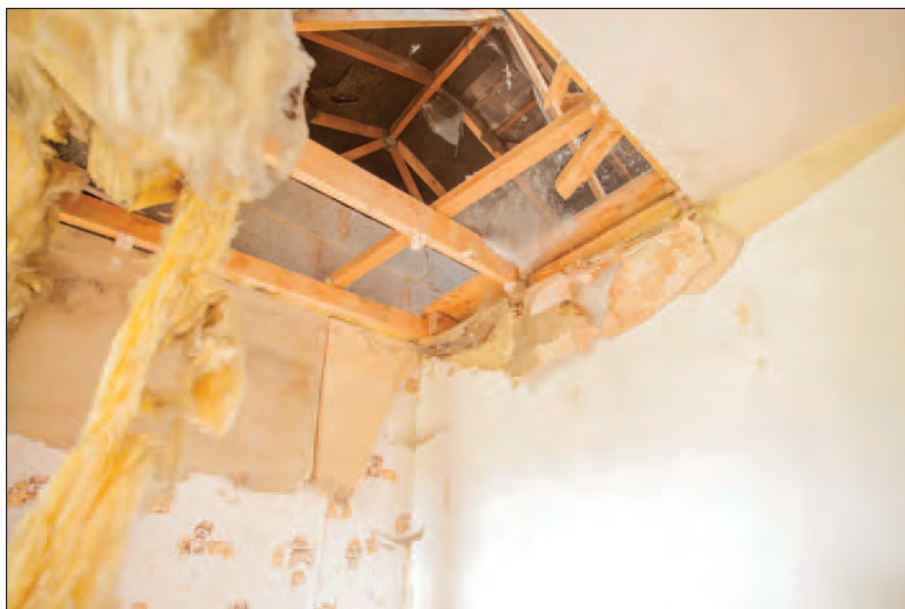
Plate 18: Number 83, room F5 with damaged ceiling showing the roof structure

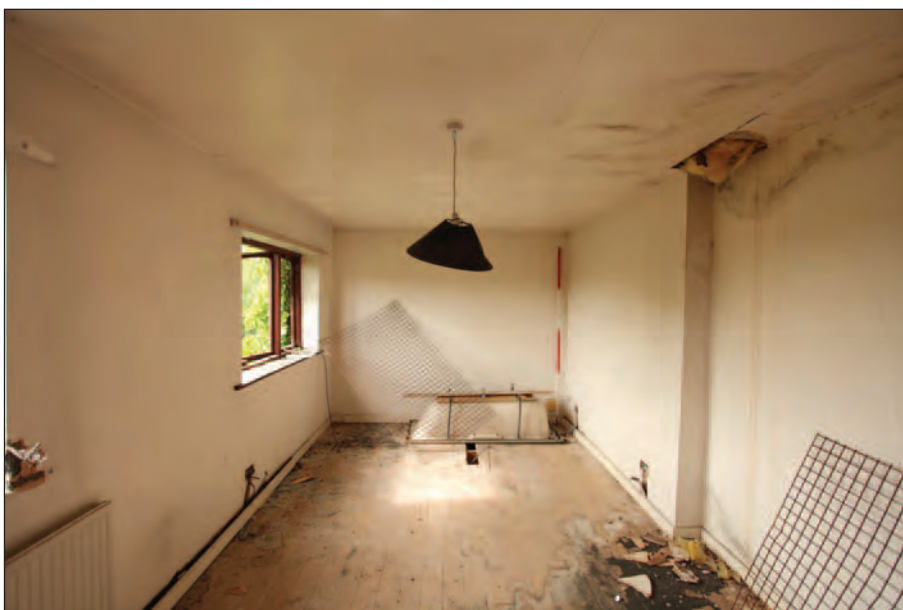
- 3.3.18 The first floor (Figure 6) was accessed from the staircase (Plate 25) which led to a small corridor, F1, with plain doorways to the adjoining rooms (Plate 27). Bedroom F2, to the north, retained its timber window of twelve lights of which the upper row consisted of an awning opening (Plate 26). Corridor F1 was divided by a stud wall with a doorway creating a small bathroom, F3, with a modern casement window within the west wall (Plates 27 and 28). The ceiling of the bathroom was partially damaged exposing the modern roof structure which also included scantling members joints with galvanised fittings.
- 3.3.19 Bedroom F4 was located to the south and contained two window openings within the south wall, one of which had retained its modern window timber frame comparable to the one observed in room G2 below it (Plate 29).

Plate 29: Number 85, room F4 viewed from the east
